# Structural Integrity of Reinforced Concrete

Texas Christian University , Department of Engineering

## Abstract

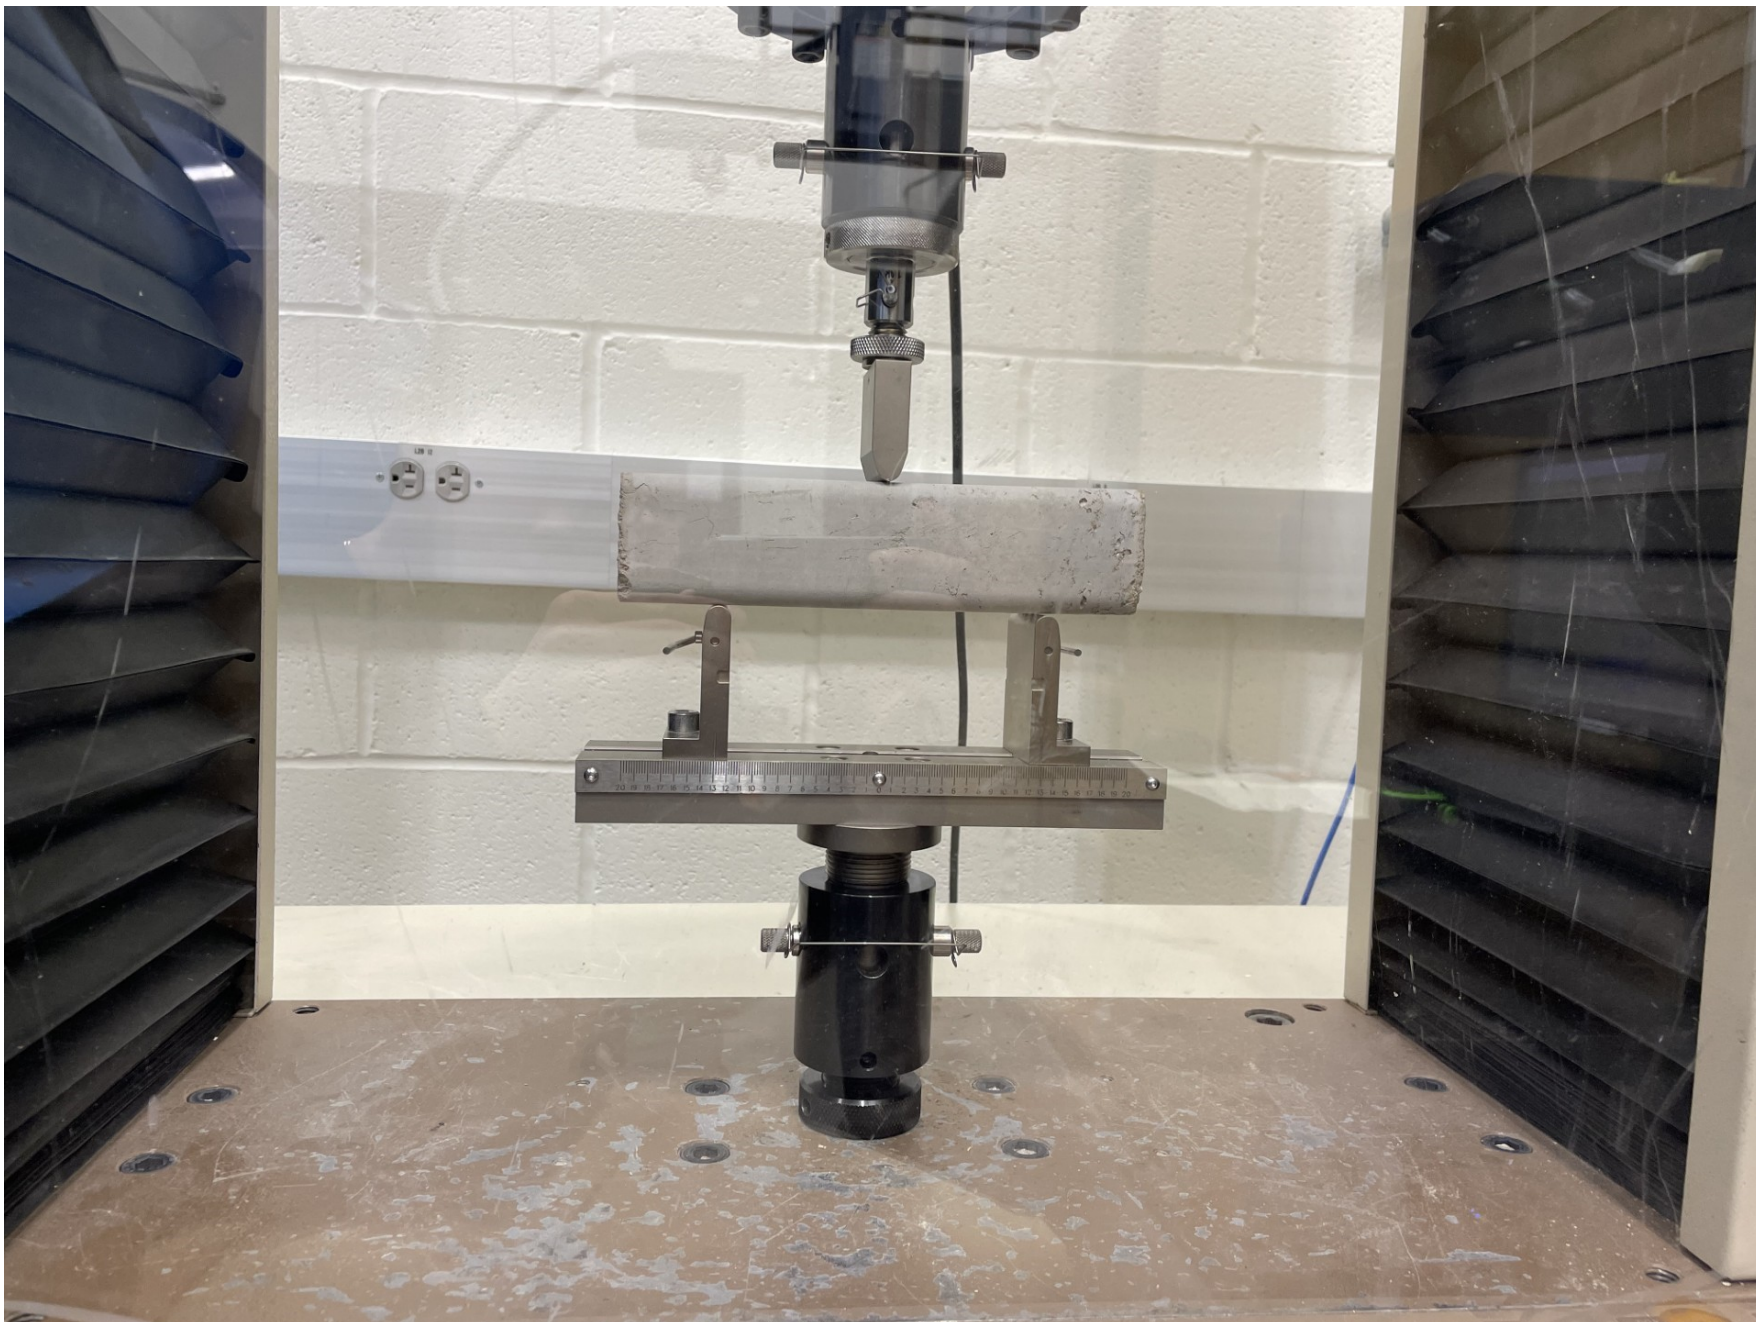
Figure 2(Three-Point Bend Test)

### Three-Point Bend Test

Beams are tested with a horizontal load as shown in the image above (Figure 1) and determines the flexural strength of a material. Deflection rate of 0.015 in/min

Fiber glass and steel rebar were tested in both compressive and flexural applications. A single 6” rod was set vertically into concrete piers for the compressive test and horizontally in beams for the flexural test. 2 piers and 2 beams contained #4 steel rebar the other 2 piers and beams contained fiberglass rebar.

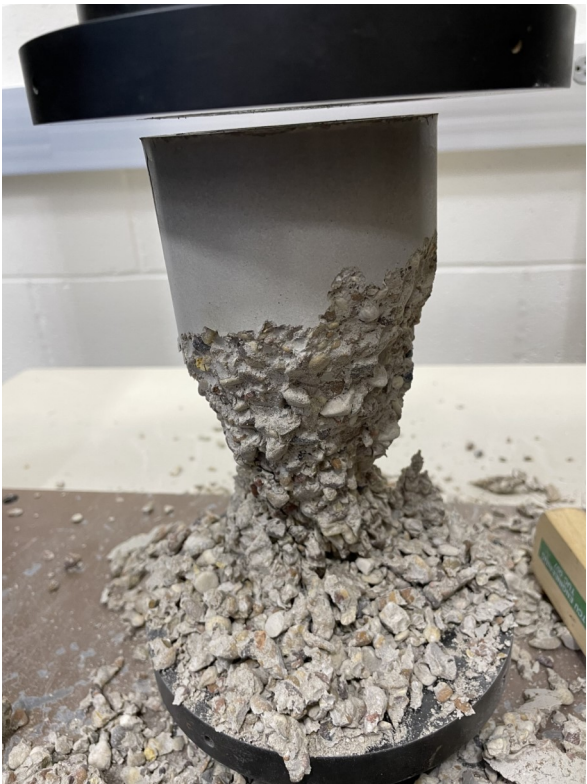
Figure 3 (Fiber glass 2 compressive failure)

Figure 4 (Fiber glass 2 compressive failure)

In the compressive test the rebar affected the mode of failure on the piers. Steel specimens experienced a shearing failure (Figure 5) while fiber glass experienced a compressive failure (Figure 3 & 4).

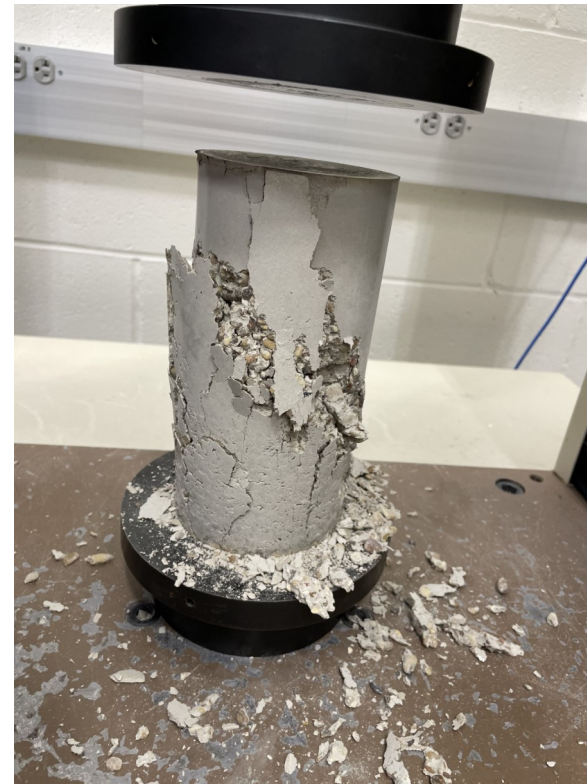
Figure 5 (Steel 1 shear failure)

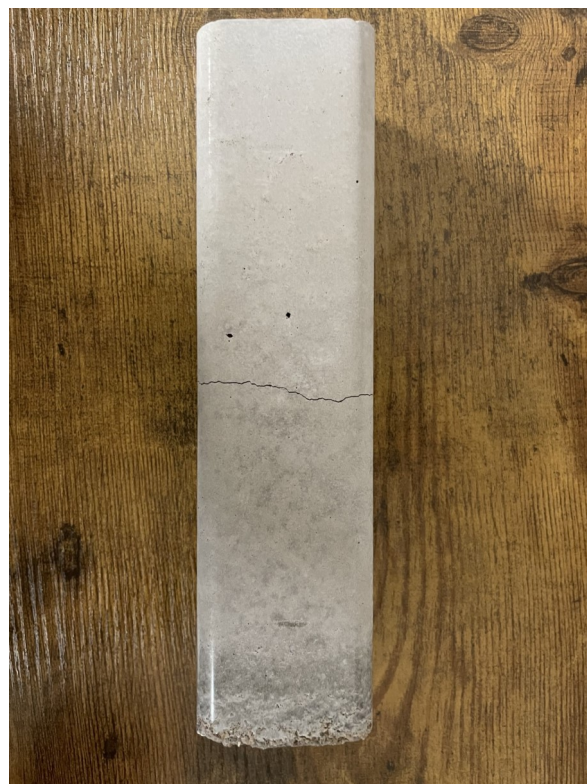
Figure 6 (Fiber glass flexural failure)

The flexural test also experienced different modes of failure. Steel samples again sheared (Figure 7) since the steel would not bend with the concrete. This caused the concrete to fail at very small deflections. The fiberglass rebar would bend with the concrete allowing for the higher deflections.

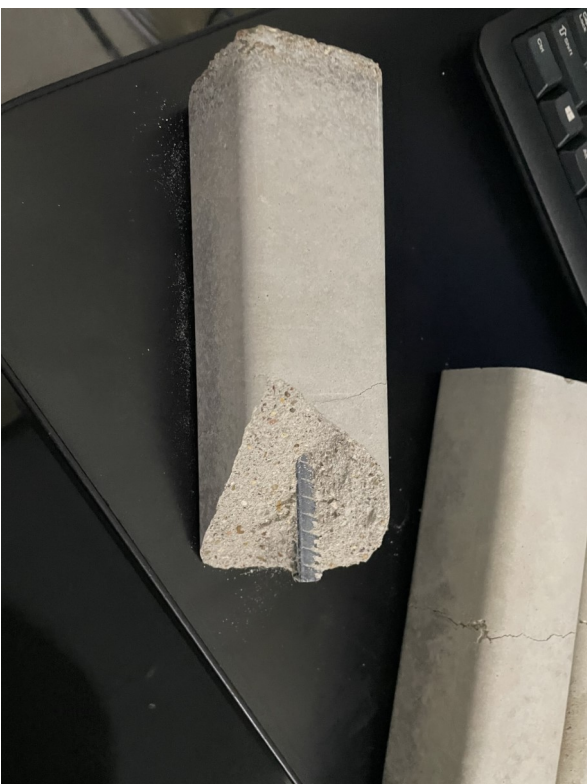
Figure 7 (Steel flexural failure)
